Operation Guide & Recommended Fitting Instructions.

SP904/3/4/5/7/8/10/11/13 Integrated Wireless Side Warning System

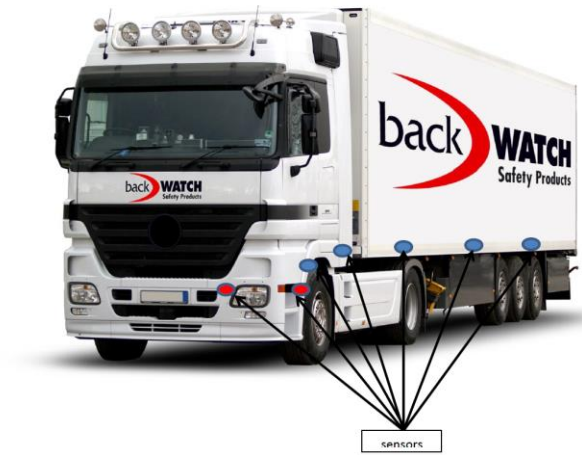
Fig 1

- B. The sensors should be located no further than 1 meter each apart
- C. See **Fig 1** for **suggested** location of sensors(different vehicles may require a different location). Please note Cross rail and TFL require sensors around front nearside area

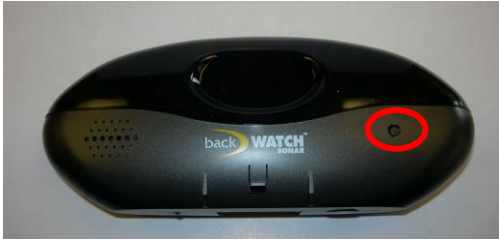
Fig 9

- A. The power cable should be connected to the CDU as highlighted in **Fig 9** and passed through the base of the CDU bracket
- B. Connect the other end of the power cable **Fig 10** to Ignition (Red) live, (black) negative. The speed wire is analogue (white) and should be connected to a suitable speed signal dependant on vehicle (should you decide not to connect this wire, sensors will be on all the time, in which case you must connect this wire to ground or a malfunction may occur), usually but not limited to **B6 or B7 (V imp) at back of tachograph or on older tachograph PIN C3. Many vehicles will have body builder plug for speed signal, but this may need to be turned on by manufacturer/dealer. The speed signal is 5v square pattern**

- C. Connect the CDU sensor wireloom **Fig 11** to CDU as highlighted in **Fig 9**
- D. NOTE CDU WIRE LOOM (fig11) HAS CONNECTIONS FOR 4 SENSORS AND ONLY USED ON SP904/4/5/7/8/10/11/13 IT IS NOT USED ON SP904/3. DO NOT PLUG CDU WIRE LOOM INTO ECU UNIT**

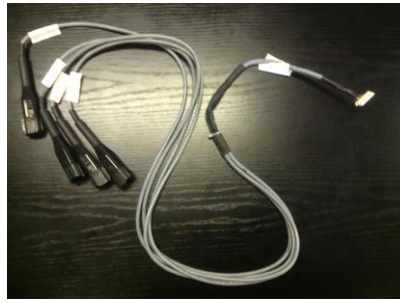
Fault	Possible Cause	Solution
On start-up CDU displays as Fig 12 . Single bleep every 3 seconds, 3 times	Sensor on CDU cable 1 is reporting a fault	<ul style="list-style-type: none"> Ensure sensor is correctly connected to cable or replace sensor
On start-up CDU displays as Fig 12 . 2 bleeps every 3 seconds, 3 times	Sensor on CDU cable 2 is reporting a fault	<ul style="list-style-type: none"> Ensure sensor is correctly connected to cable or replace sensor
On start-up CDU displays as Fig 12 . 3 bleeps every 3 seconds, 3 times	Sensor on CDU cable 3 is reporting a fault	<ul style="list-style-type: none"> Ensure sensor is correctly connected or replace sensor
On Start-up CDU displays as Fig 12 . Single bleep followed by multiple bleeps	Multiple sensor fault reported or faulty CDU or faulty CDU wireloom Single bleep cable 1 2 bleeps cable 2 3 bleeps cable 3 4 bleeps cable 4	<ul style="list-style-type: none"> Replace corresponding sensor first, if this does not resolve the issue. CDU should be replaced. Finally replace CDU wireloom

Fault on sensor 2 connected to CDU and fault on Sensor C connected to rear ECU loom. CDU will display as **fig 15** bleep 3 times, it will then display as **fig 12** and bleep 2 times. It will follow this procedure a total of 3 times before switching off

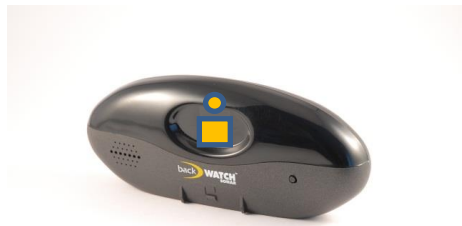
On Start up CDU displays as Fig 13,14 or 15 Single bleep every 3 seconds 3 times	Sensor on ECU cable Left Fig 13 Right Fig 14 Rear Fig 15 Reporting fault on cable A	<ul style="list-style-type: none"> Ensure sensor correctly connected or replace sensor

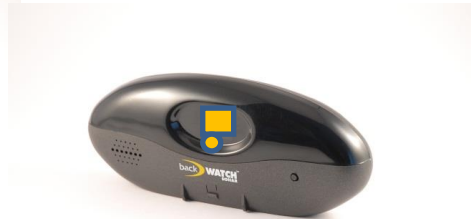
fig 14

On Start up CDU displays as Fig 13,14 or 15 2 bleeps every 3 seconds 3 times	Sensor on ECU cable Left Fig 13 Right Fig 14 Rear Fig 15 Reporting fault on cable B	<ul style="list-style-type: none"> • Ensure sensor correctly connected or replace sensor
On Start up CDU displays as Fig 13,14 or 15 3 bleeps every 3 seconds 3 times	Sensor on ECU cable Left Fig 13 Right Fig 14 Rear Fig 15 Reporting fault on cable C	<ul style="list-style-type: none"> • Ensure sensor correctly connected or replace sensor
On Start up CDU displays as Fig 13, 14 or 15 alternatively with single and multiple bleeps each 3 times every 3 seconds	Sensor failure on more than one ECU wire loom, fault ECU or Faulty wireloom 1 bleep Sensor A 2 bleeps Sensor B 3 bleeps Sensor C	<ul style="list-style-type: none"> • Replace corresponding sensor first, if this does not resolve issue then replace ECU, finally replace Loom
System seems to operate very intermittently	Sensor holes may be too tight	<ul style="list-style-type: none"> • Move sensors slightly out of their hole and check system operates. If so slightly enlarge aperture using a file and relocate sensor
